Report Identification 5213 Gulfport Report# HG001 Lake

<b>Date:</b> 7/11/2007	<b>Time:</b> 1:45 PM	<b>Report ID:</b> HG001 Lake
<b>Property:</b> 5213 Gulfport Georgetown, TX 78626	<b>Customer:</b> Mr. Don Lake Mrs. Tina Lake	<b>Real Estate Professional:</b>

### Professional Inspection Services

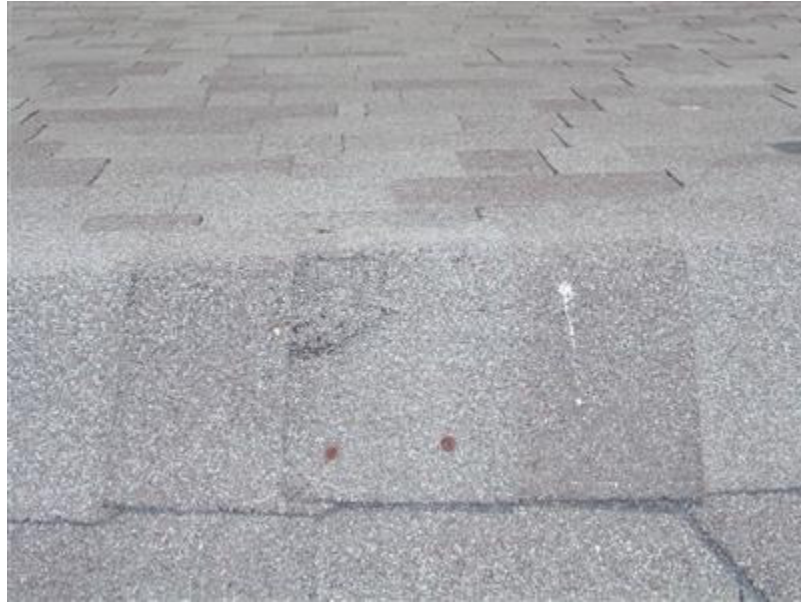
C. Picture 1

<input checked="" type="checkbox"/>	<input type="checkbox"/>	<input type="checkbox"/>	<input type="checkbox"/>	<p><b>C. Roof Covering (If the roof is inaccessible, report the method used to inspect)</b>  <b>Viewed roof covering from:</b> Walked roof  <b>Roof Ventilation:</b> Passive  <b>Roof Covering:</b> Asphalt/Fiberglass  <i>Comments:</i>            The roof covering looks to be in great shape (composition shingles). No damage was detected.  <u><b>Exposed nail heads at either the vent &amp; roof flashing or at the composition shingles can allow water to penetrate past the roof covering given enough time.</b></u> <i>As the exposed portion of the nail rusts, more space will become available between the nail and the roofing material for water to penetrate. This condition can usually be remedied by sealing or caulking affected areas.</i></p>

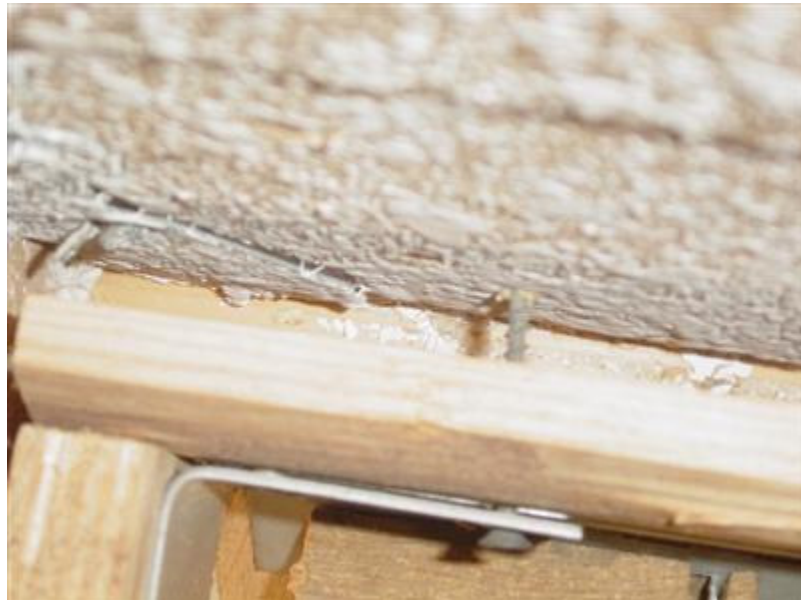
D. Picture 1

The pull down stairs is secured with drywall screws which is against the manufacturers recommendations. Injury could result if not repaired. A qualified person should repair or replace as needed.

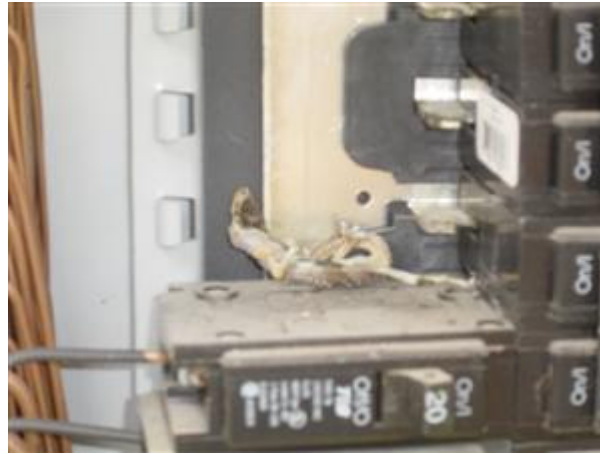
A. Picture 1

The main panel box is located at the outside. The main panel box is located at the outside. The panel is missing knockouts (DANGEROUS) allowing rodents and lizards to enter the main panel. This is a safety issue that needs to be corrected. A qualified licensed electrician should correct as needed.

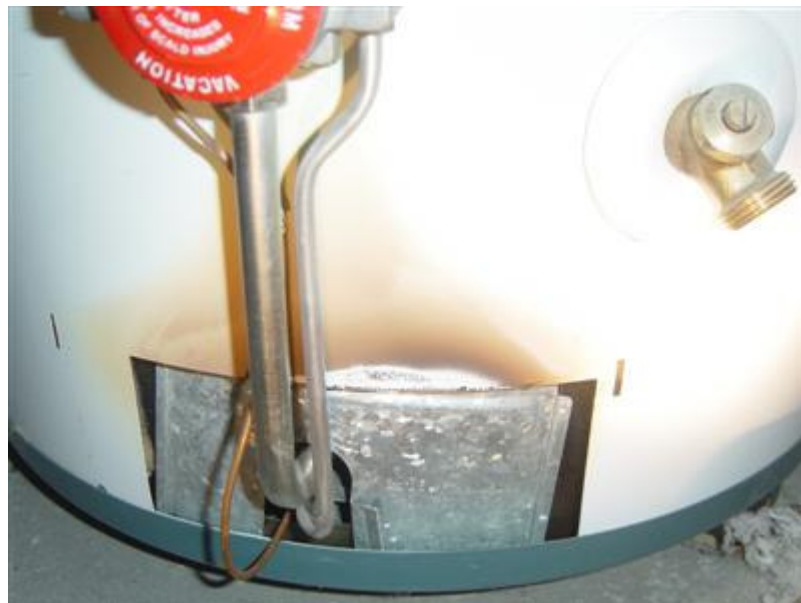
C. Picture 1

| <input checked="" type="checkbox"/> | <input type="checkbox"/> | <input type="checkbox"/> | <input checked="" type="checkbox"/> | <b>C. Water Heating Equipment (Report as in need of repair those conditions specifically listed as recognized hazards by TREC Rules)</b><br><b>Water Heater Power Source:</b> Gas (quick recovery)<br><b>Water Heater Capacity:</b> 50 Gallon (2-3 people)<br><b>Water Heater Manufacturer:</b> RHEEM<br><i>Comments:</i><br><input checked="" type="checkbox"/> The water heater shows signs of flame rollout. Upon ignition of the water heater I was not able to duplicate the condition. This is considered a <b>SERIOUS HAZARD</b> and I recommend that a licensed plumbing professional evaluate and repair as necessary. |

The water heater shows signs of flame rollout. Upon ignition of the water heater I was not able to duplicate the condition. This is considered a **SERIOUS HAZARD** and I recommend that a licensed plumbing professional evaluate and repair as necessary.
