## PROPERTY INSPECTION REPORT

**Concerning:** 12600 Hoof Court, Austin, TX 78732  
 \_\_\_\_\_  
 (Address or Other Identification of Inspected Property)

**By:** Charles A. Chaudoir / Professional Inspection Services      7/24/2007  
 \_\_\_\_\_  
 (Name and License Number of Inspector)      (Date)

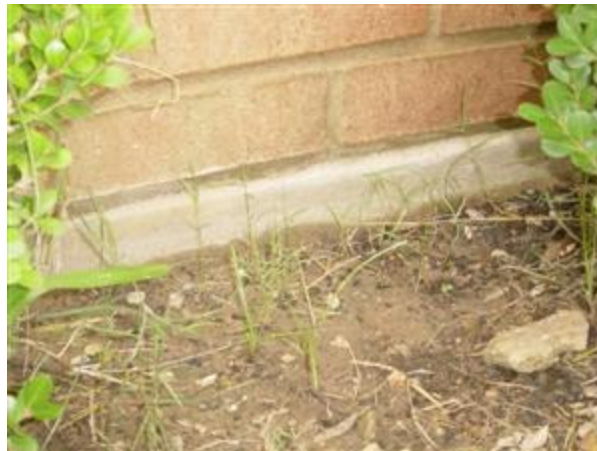
High soil was detected along the perimeter of the foundation in various locations. Soil should be at least 6" from masonry siding and 8" from all other types of siding material. Also, the shrubs should be trimmed back so that they do not come in contact with the structure. This condition can lead to premature wear and also invites water, insect and vermin intrusion.

B. Picture 1 High Soil

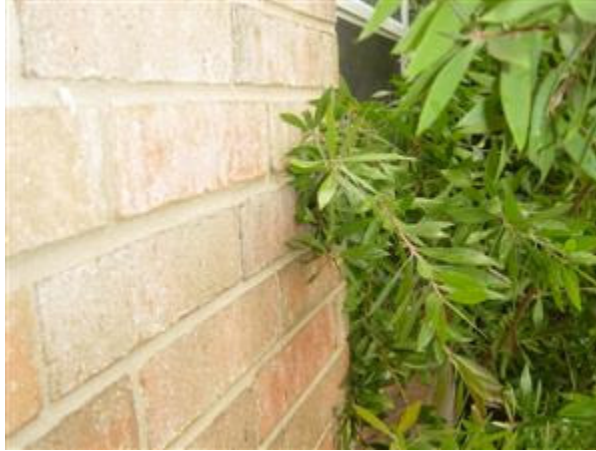
B. Picture 2 Shrubs too Close to House

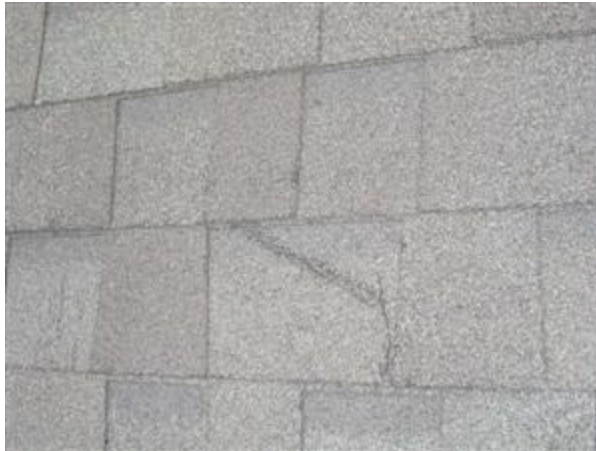
The roof covering has hairline cracks in various areas. This is possibly from a manufacturer defect. The roof could leak. I recommend repair or replace.

C. Picture 1 Damaged/cracked shingle

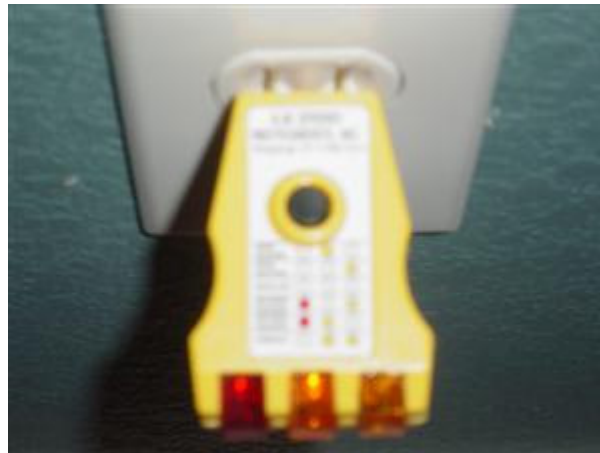
Several "three-prong" outlets are not grounded in the Guest bedroom, Master Bedroom and playroom. This is a safety issue that needs to be corrected . Electrical issues are considered a hazard until repaired. A qualified licensed electrician should correct as needed.

B. Picture 1 Open Ground - Guest Bedroom

Several "three-prong" outlets are not grounded in the Guest bedroom, Master Bedroom and playroom. This is a safety issue that needs to be corrected. Electrical issues are considered a hazard until repaired. A qualified licensed electrician should correct as needed.

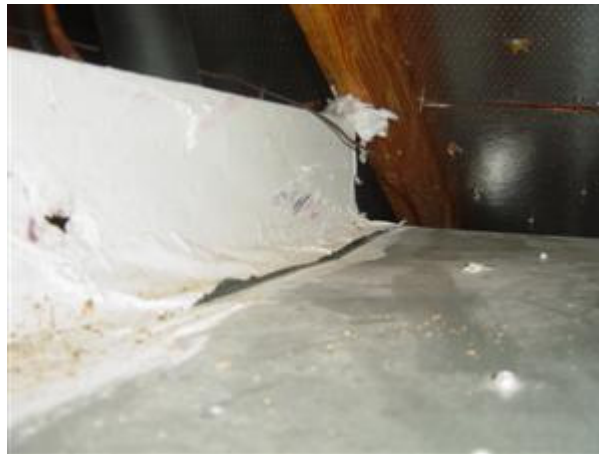
The connection between the return air vent and the heating/cooling unit is damaged. I recommend that it be repaired by a qualified HVAC contractor.

C. Picture 1 Damaged connection - return air connection.
